1963 Fiat 500 Giardiniera D

By Douglas Comrie

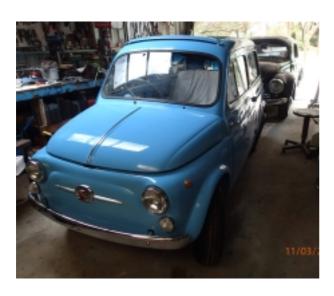
The knee pads purchased from Europe were as useful as tits on a bull as they were for a left hand drive vehicle. Consequently we stripped them down and used the metal frame as a base, then reformed and covered them with matching vinyl.

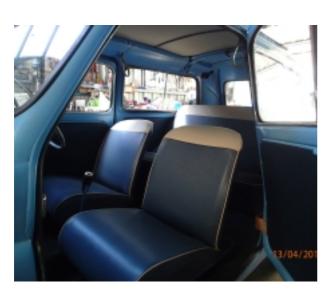
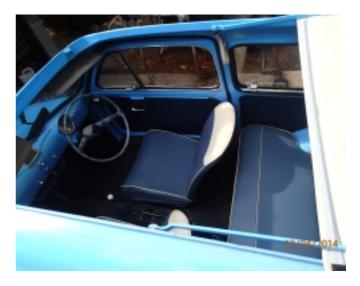
When fitting the upholstery, the temperature in the shed was around 52 degrees Celsius. This kept the vinyl soft and supple. We made the door and interior panels up from scratch, as there was nothing to use as reference.
